Shenzhen ORT Technical Services Co., Ltd.

TEST REPORT

Report Number ORTSZ240830112001-1					
Sample Name:	Smartphone		Applicant:	Shenzhen Huafurui Technology Co., Ltd.	
Model:	KINGKONG POWER 3		Address:	Unit 601-03, 6/F, Block A, Building 1, Ganfeng Technology Building, No. 993 Jiaxian Road, Xiangjiaotang Community, Bantian Street, Longgang District, Shenzhen, China	
Spec:	Black		Vendor or Supplier:	Shenzhen Huafurui Technology Co., Ltd.	
Brand:	CUBOT		Address:	The same as above	
Sample Quantity:	6 Pcs		Manufacturer:	Shenzhen Huafurui Technology Co., Ltd.	
Specimen Source:	Submitted by applicant		Address:	The same as above	
Received Date:	2024.09.01	Detection Date:	2024.09.02~ 2023.09.05	Report Date:	2024.09.07
Test Requirement:	For further details, please refer to the following page(s).				
Test Item:	1.IPX9K Test; 2.IP6KX Test; 3.IP6X Test; 4.IPX8 Test; 5.Vibration Test; 6.Drop Test; 7.Combined Temperature and Shock Test.				
Decision Rules:	For further details, please refer to the following page(s).

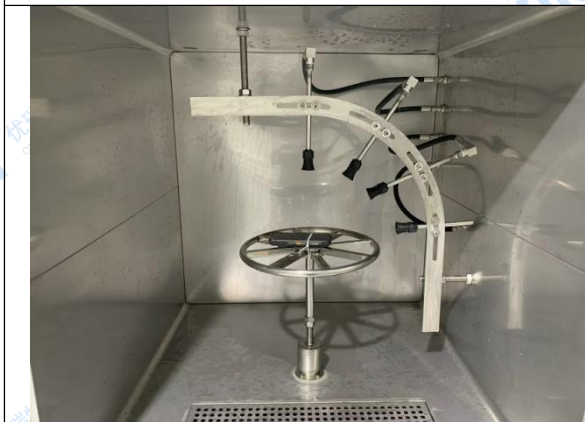
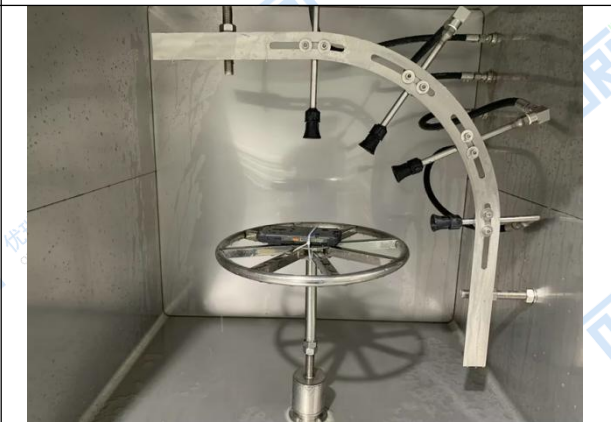
Fig.3 Test setup

Fig.4 Test setup

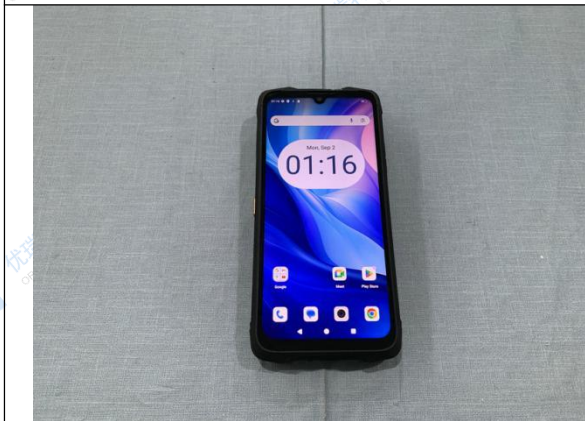
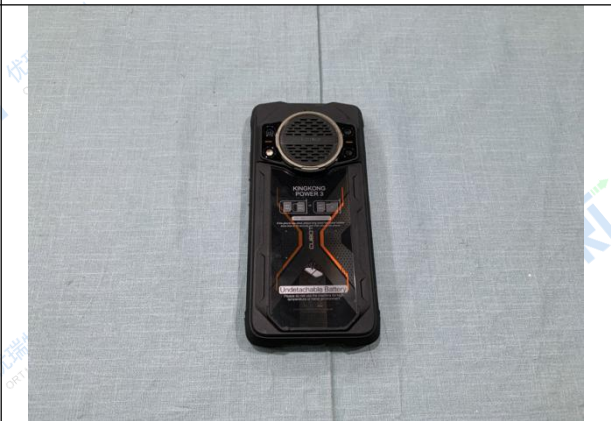
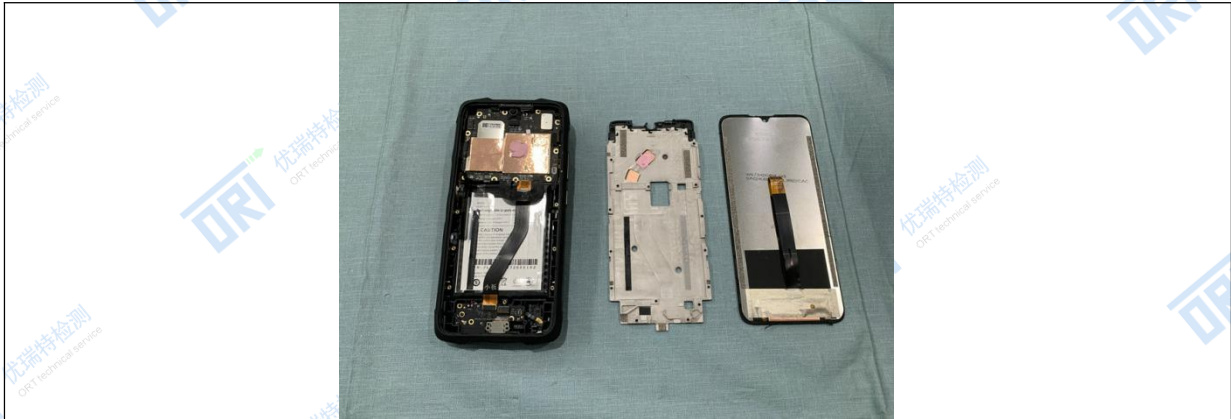
Sample No.	Inspection after test	Conclusion
1#	The appearance of the sample has no visible damage, the startup function is normal, and there is no water inside.	Pass

Fig.5 Power on inspection after test

Fig.6 Appearance inspection after test

Fig.7 Appearance inspection after test

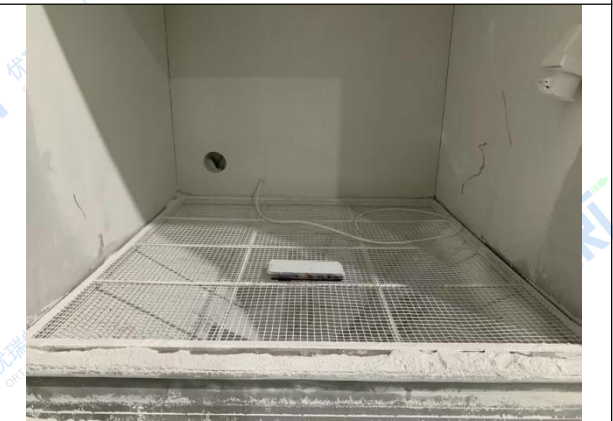
Fig.10 Test setup

Fig.11 Test setup

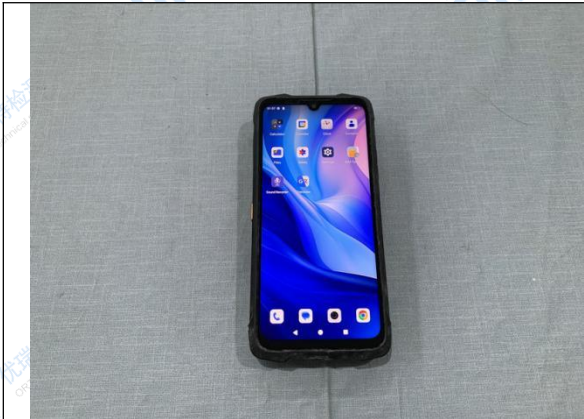
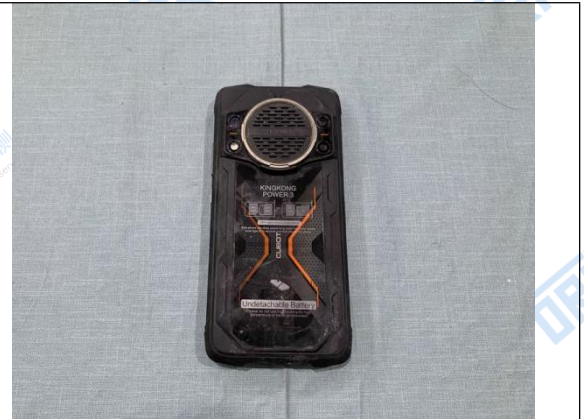
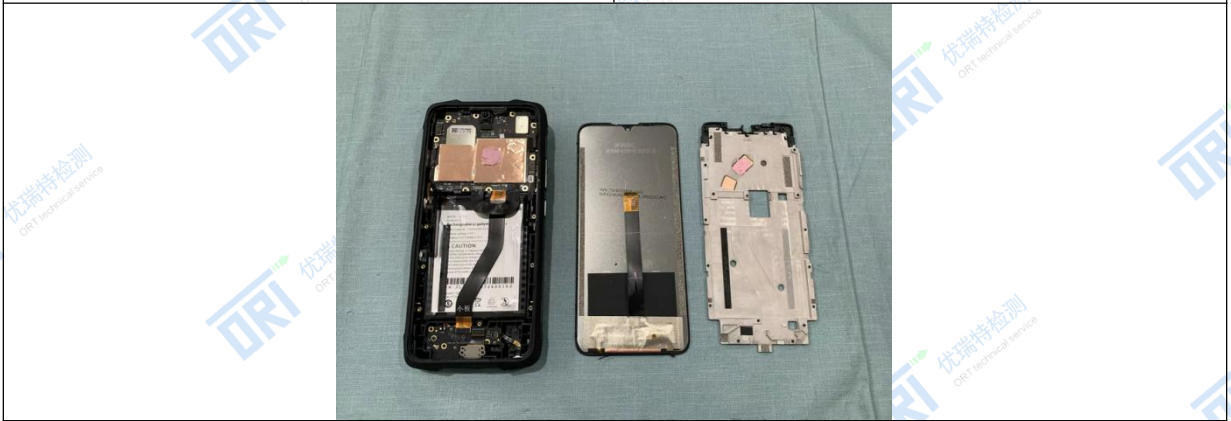
Sample No.	Inspection after test	Conclusion
2#	The appearance of the sample has no visible damage, the startup function is normal, and there is no dust inside.	Pass

Fig.12 Power on inspection after test

Fig.13 Appearance inspection after test

Fig.14 Appearance inspection after test

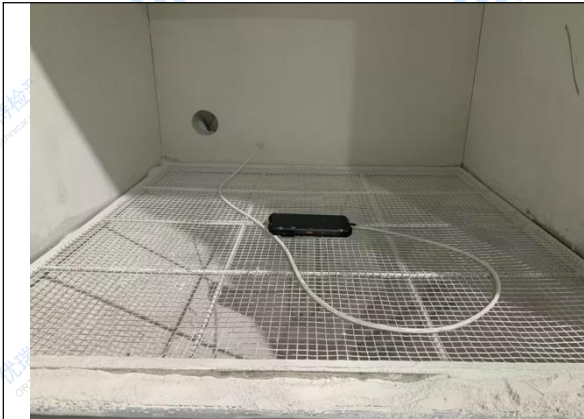
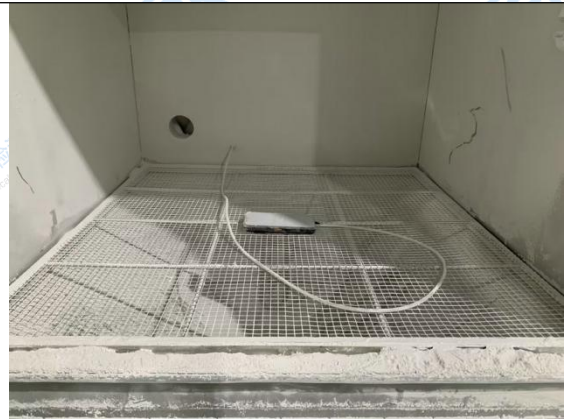
Fig.17 Test setup

Fig.18 Test setup

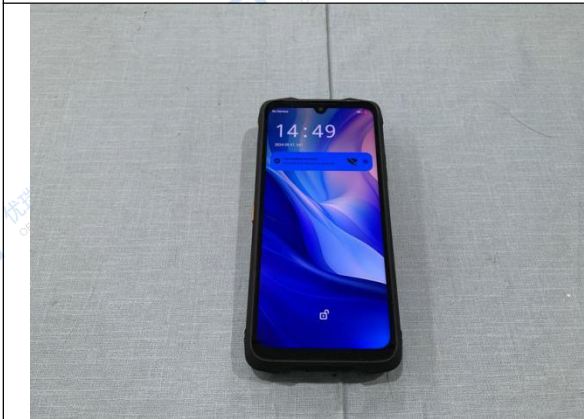
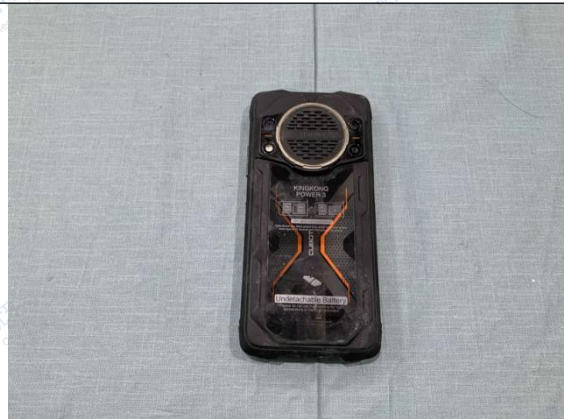
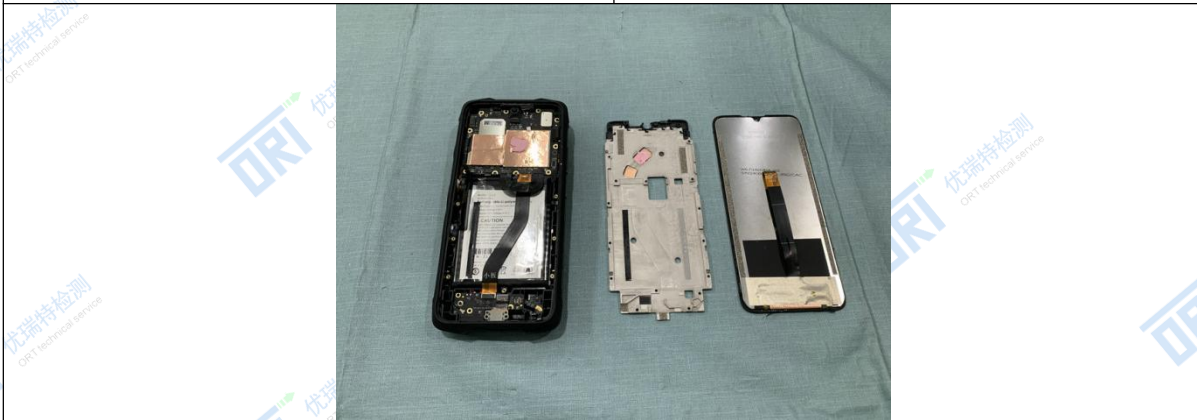
Sample No.	Inspection after test	Conclusion
3#	The appearance of the sample has no visible damage, the startup function is normal, and there is no dust inside.	Pass

Fig.19 Power on inspection after test

Fig.20 Appearance inspection after test

Fig.21 Appearance inspection after test

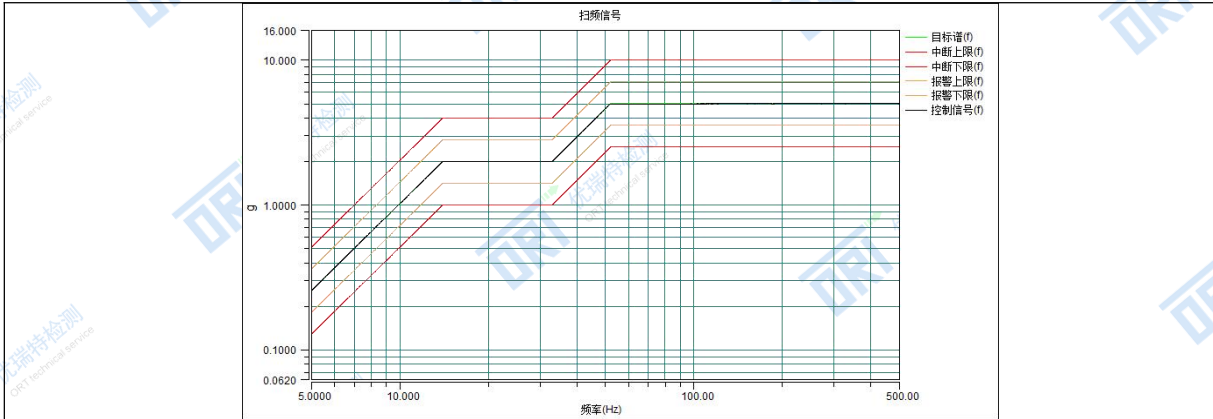
Frequency (Hz)	Acceleration (g)	Displacement (mm)	Test axis	Test time
5~14	/	5.08	X, Y, Z axis	2 h/axis
14~33	2	/		
33~52	/	0.91		
52~500	5	/

Fig.33 Test Spectrum

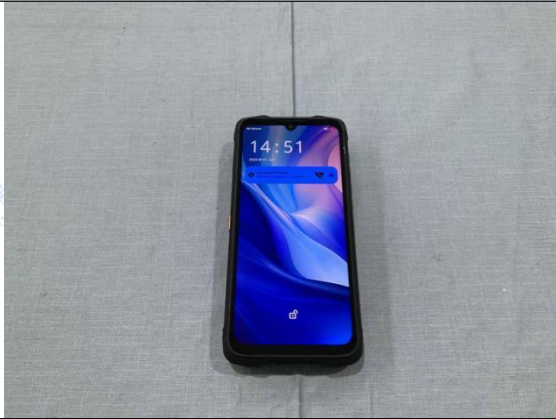
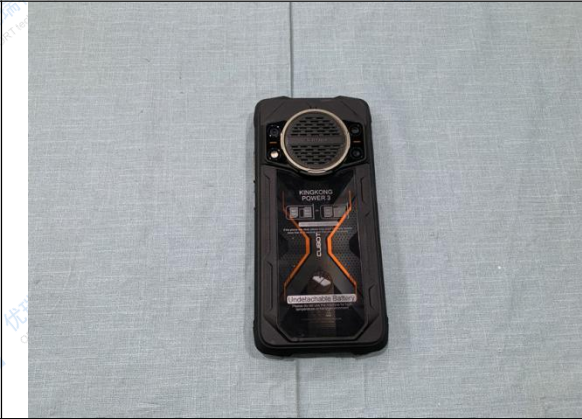
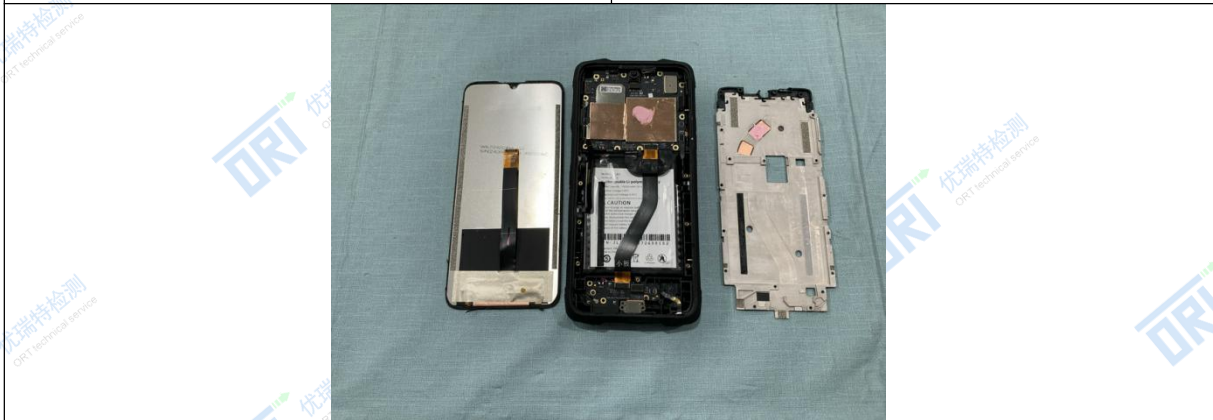
Sample No.	Inspection after test	Conclusion
5#	The appearance of the sample is not visible damage, the startup function is normal, and the internal structure is not damaged.	Pass

Fig.34 Power on inspection after test

Fig.35 Appearance inspection after test

Fig.36 Appearance inspection after test

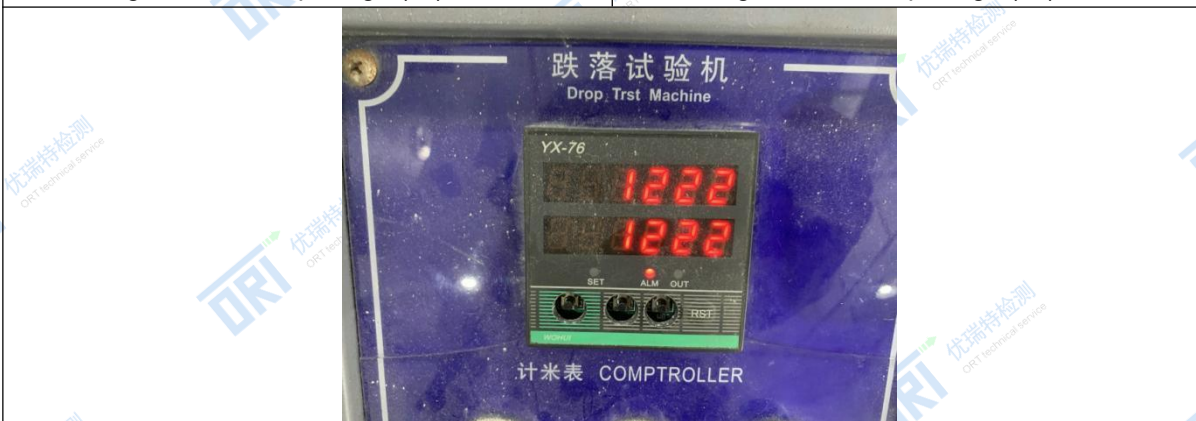
Height of drop: 122 cm

Fig.65 Drop height

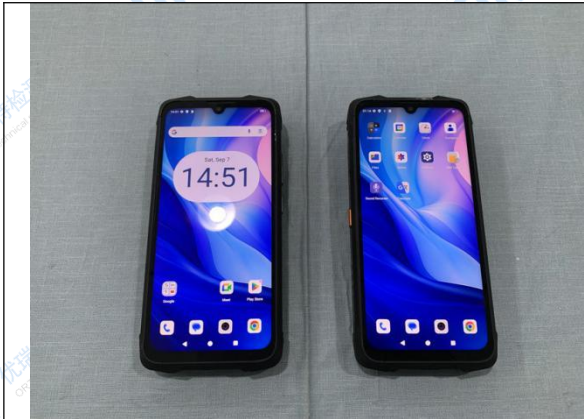
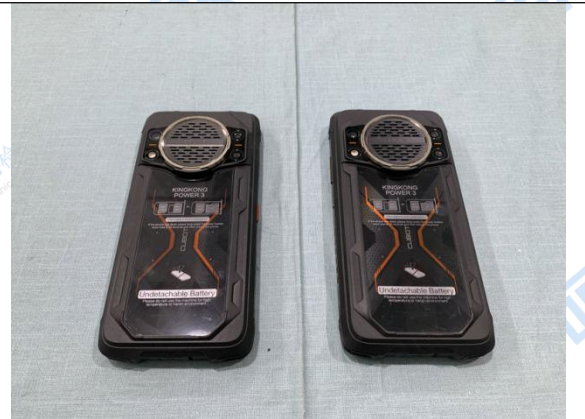
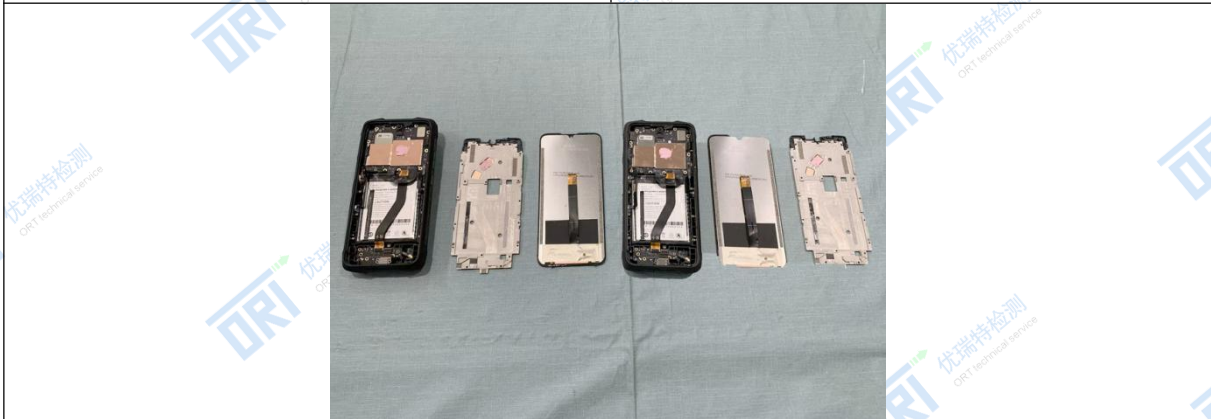
Sample No.	Inspection after test	Conclusion
5#、6#	The appearance of the sample is not visible damage, the startup function is normal, and the internal structure is not damaged.	Pass

Fig.66 Power on inspection after test

Fig.67 Appearance inspection after test

Fig.68 Appearance inspection after test

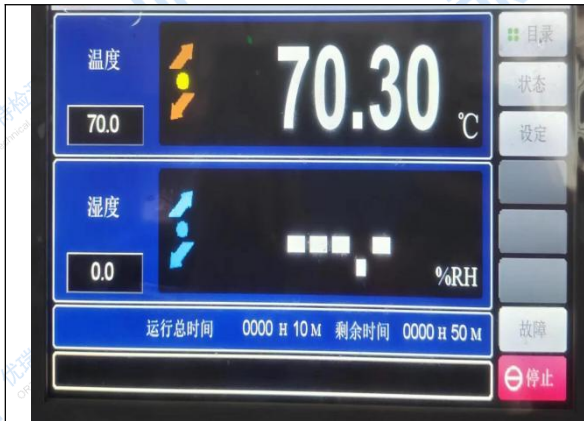
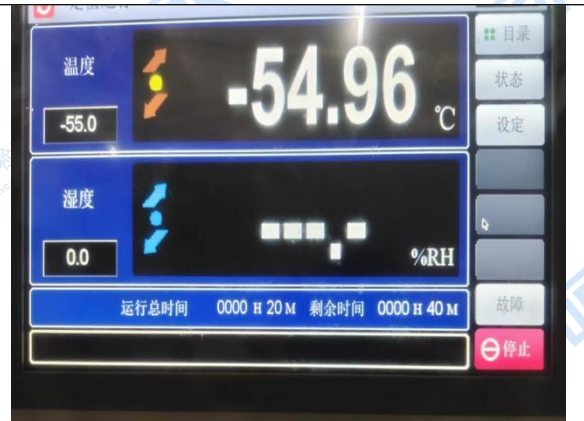
Shock Test Parameter		Temperature Test Parameter
Pulse Shape:	Half Sine	-55°C, 70°C.
Peak Acceleration:	30 g	
Pulse Duration:	6 ms	
Test Orientation:	±X, ±Y, ±Z axis

Fig.71 Temperature: 70°C

Fig.72 Temperature: -55°C

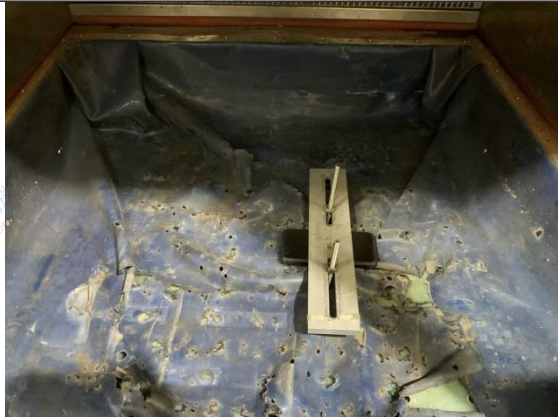
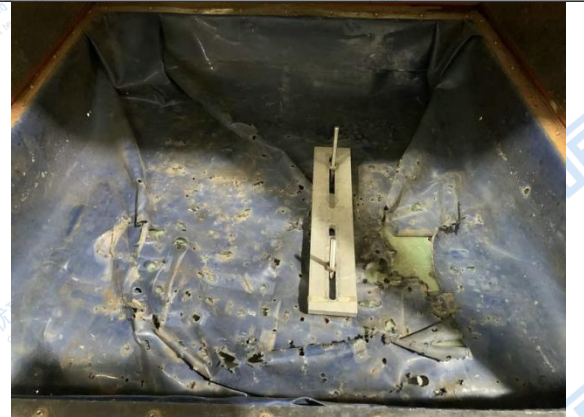
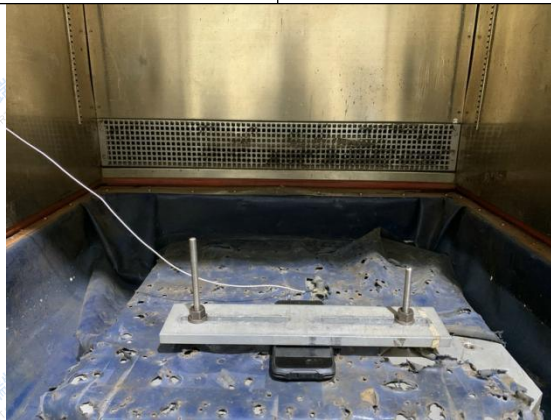
Fig.73 Test setup (X axis)

Fig.74 Test setup (Y axis)

Fig.75 Test setup (Z axis)

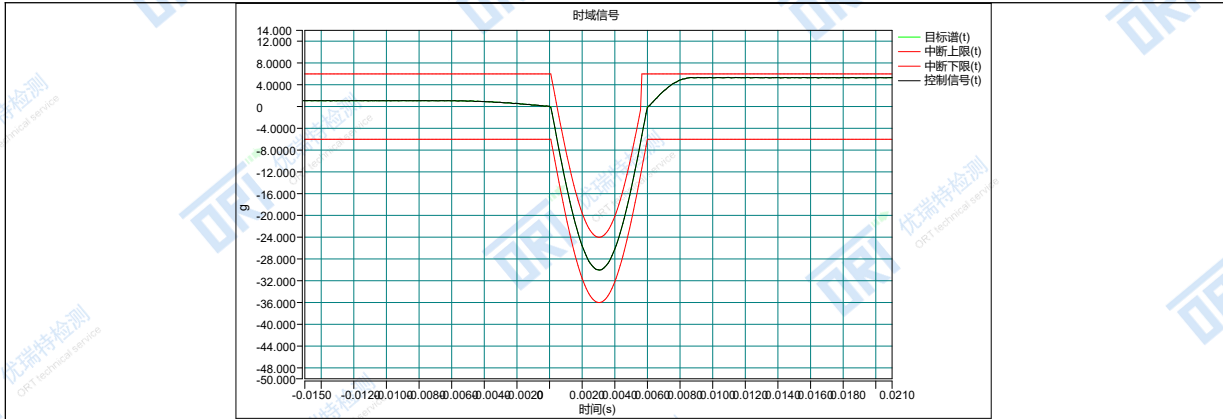
Fig.76 Test Curve (+)

Fig.77 Test Curve (-)

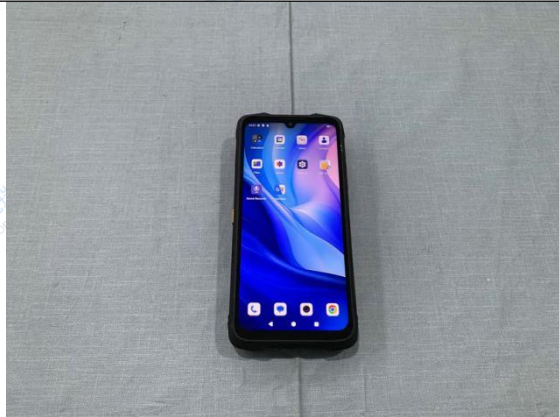
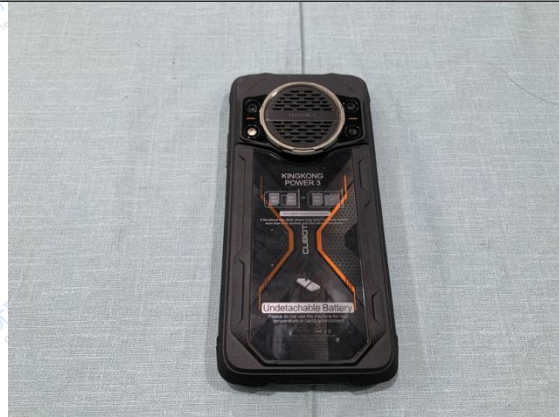
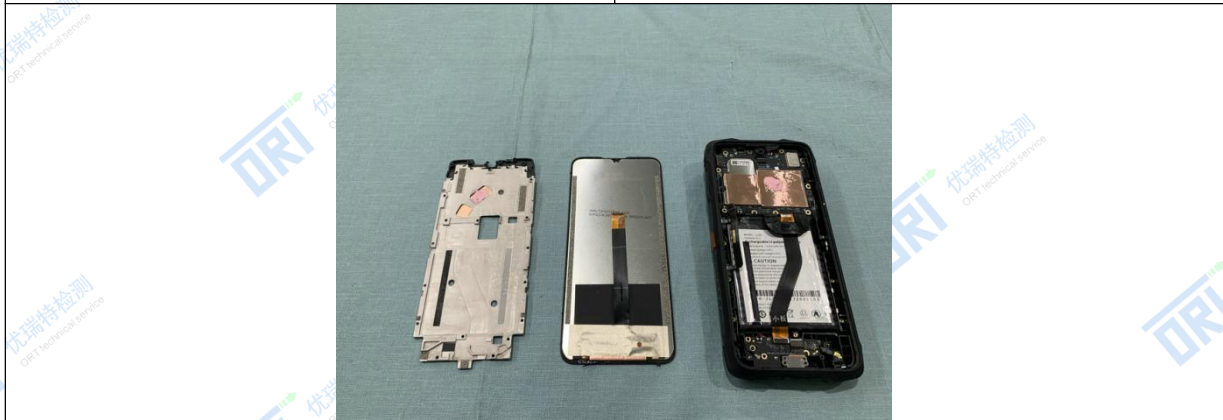
Sample No.	Inspection after test	Conclusion
6#	The appearance of the sample is not visible damage, the startup function is normal, and the internal structure is not damaged.	Pass

Fig.78 Power on inspection after test

Fig.79 Appearance inspection after test

Fig.80 Appearance inspection after test
